# **Dam Safety Assessment of CCW Impoundments**

## **GenOn/NRG CHESWICK POWER STATION**

November 6, 2013

**O'BRIEN & GERE**  
[www.obg.com](http://www.obg.com)

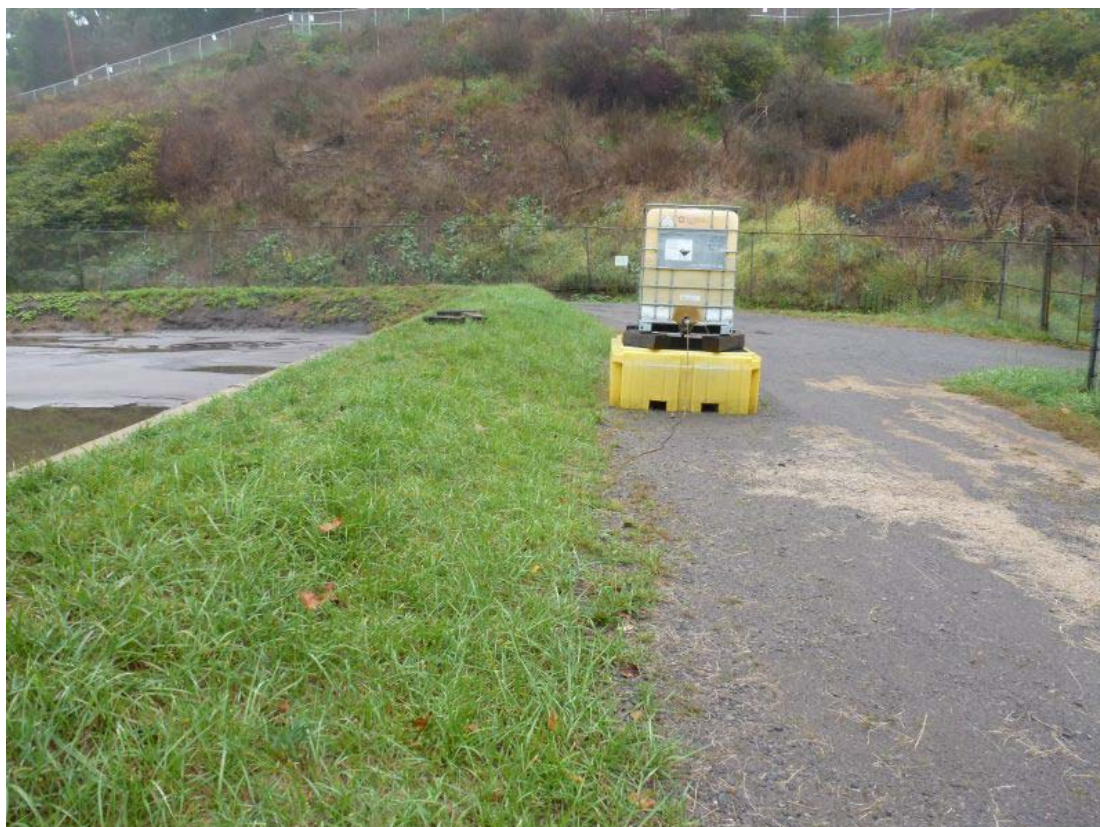
Photo Number:  
6

Description:  
Bottom Ash  
Recycle Pond  
303 north  
embankment.  
Lack of  
vegetation on  
west inboard  
slope visible in  
background.  
Natural hill on  
west side of ash  
ponds in  
background.

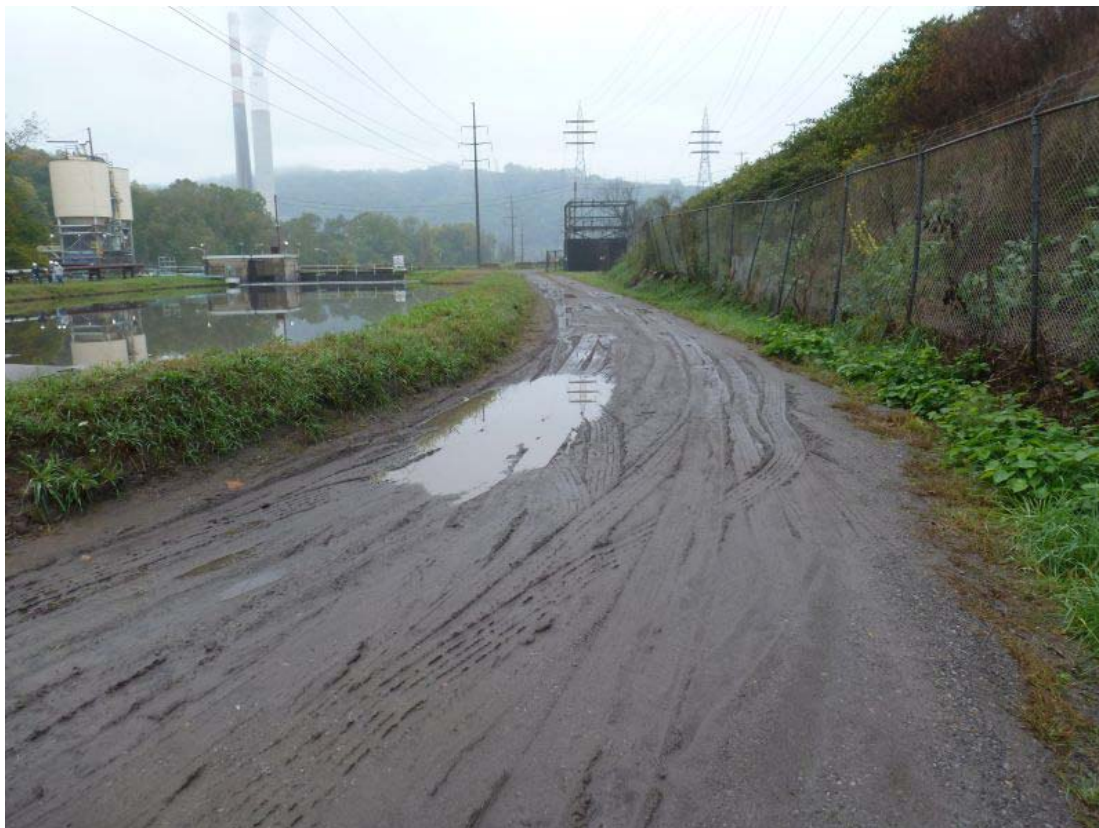
Date:  
9/27/12Photo Number:  
9Photographer:  
DDWOrientation:  
East

Description:  
Bottom Ash  
Recycle Pond  
303 western  
embankment  
and access  
road. Note  
some ponding  
on access road  
and natural  
hillside west of  
ash ponds.

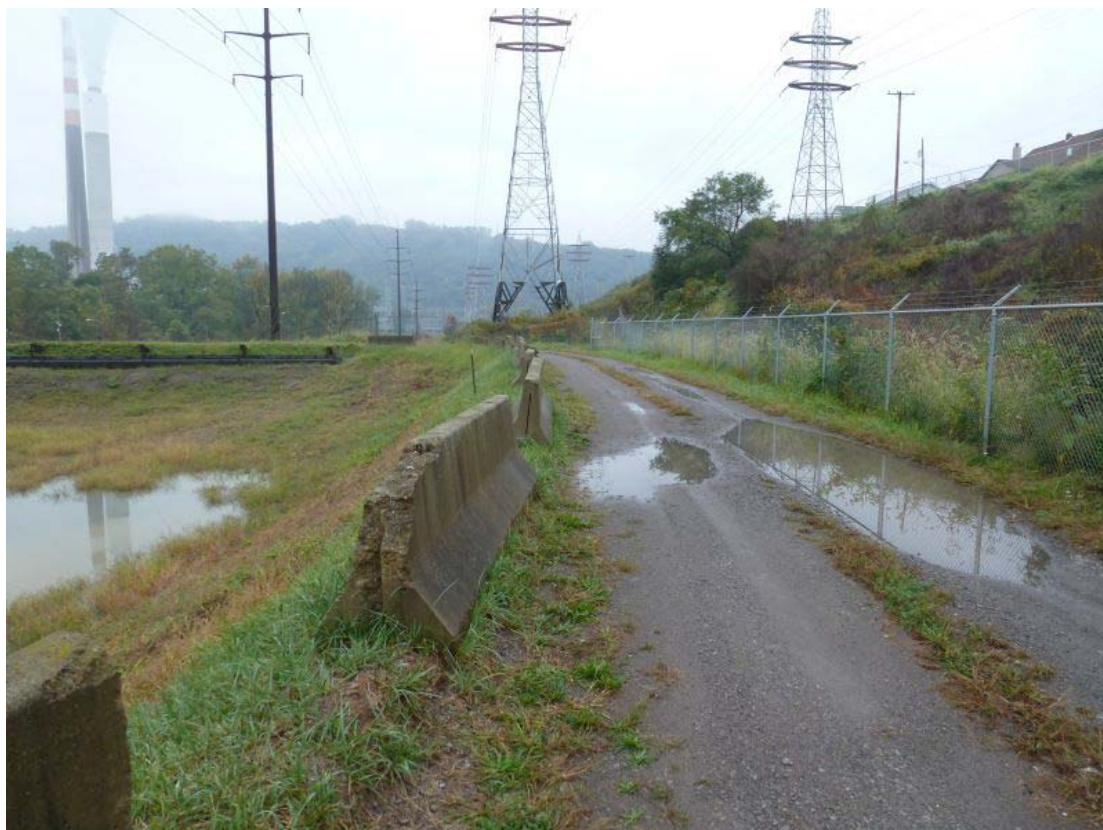
Date:  
9/27/12Photo Number:  
11Photographer:  
DDWOrientation:  
East

Description:  
Emergency Ash  
Pond 203  
western and  
southern  
inboard slopes,  
western access  
road with  
ponding, and  
natural hillside  
on west side of  
ash ponds.

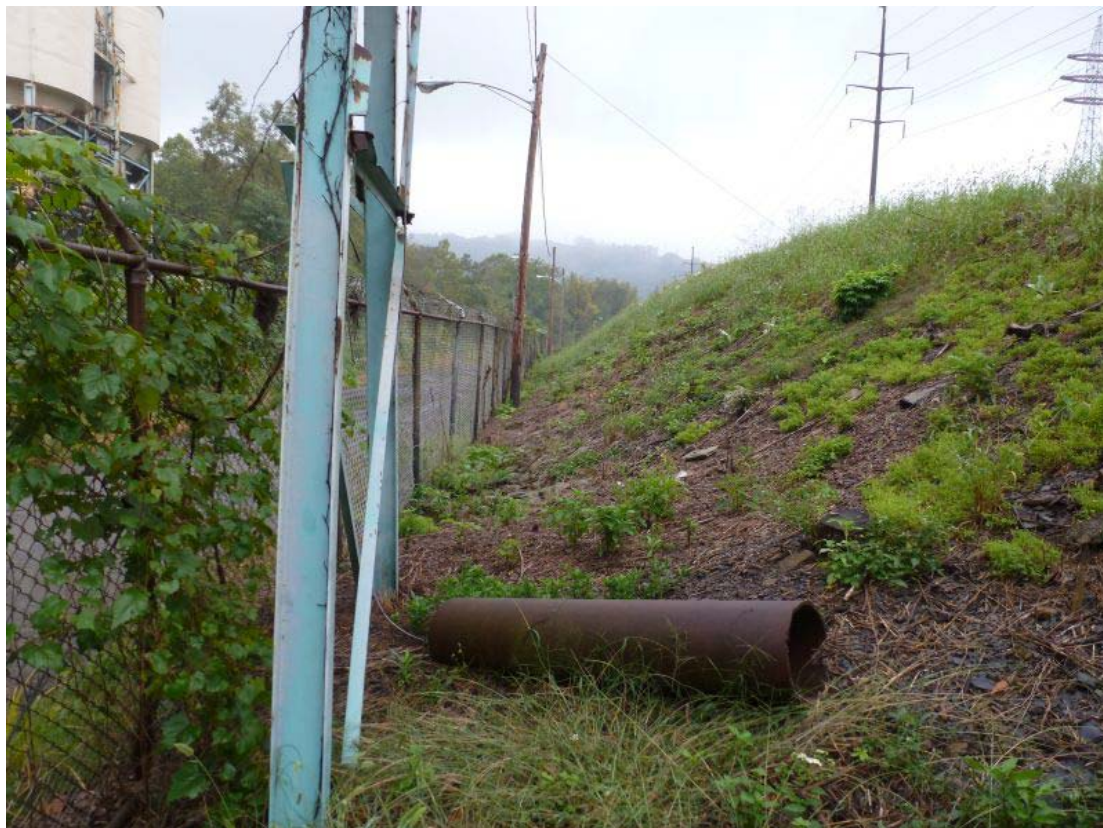
Photo Number:  
13

Description:  
Emergency Ash  
Pond 203  
eastern  
embankment/  
outboard slope.

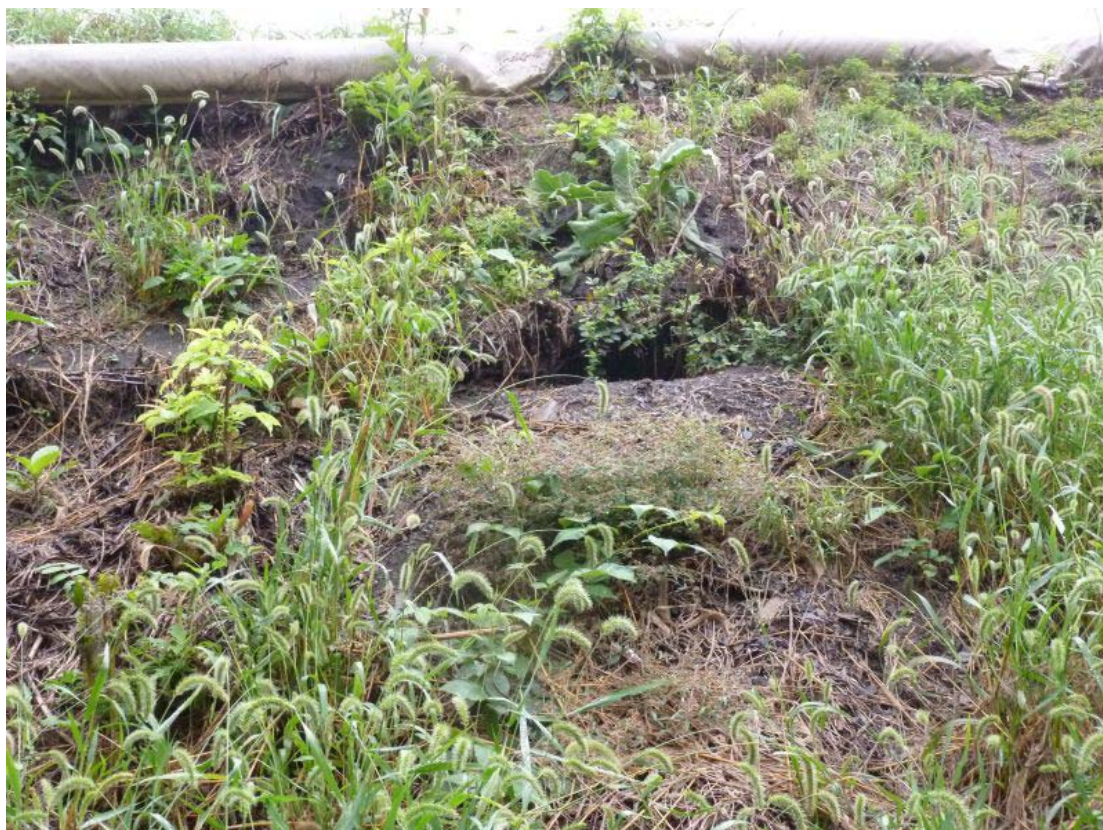
Photo Number:  
14

- | The southern embankment outboard slope appeared in fair condition with some inadequate vegetation and no undesirable vegetation.
- | The eastern embankment outboard slope had been cleared of shrubs and trees earlier in the year based on discussions with plant personnel. It was lacking vegetation in several areas likely cleared earlier in the year, showed some erosion and at least one animal burrow. There was some rip rap near the toe.

Description:  
Emergency Ash  
Pond 203  
eastern  
embankment/  
outboard slope  
erosion and  
animal burrow.

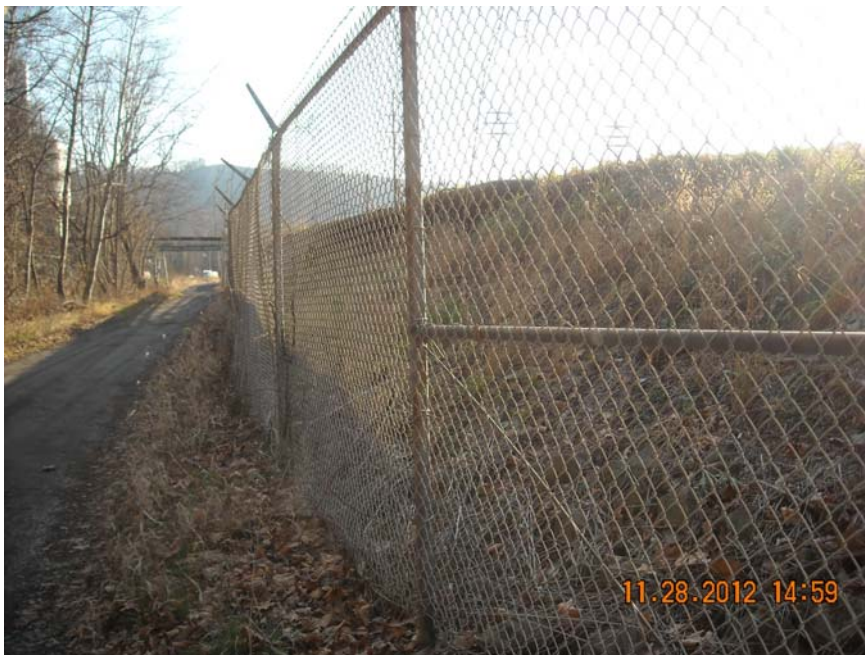
View of the Bottom Ash Pond (BAP) looking south depicting slopes which appears to be steeper than 1.5 Horizontal to 1 Vertical. .

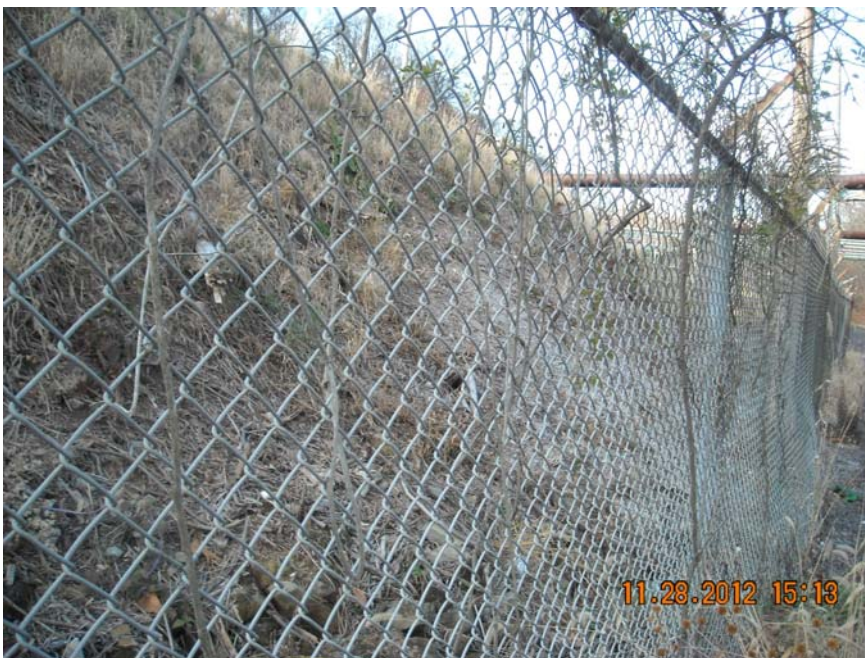
Photograph 2

View of the Emergency (BAP) looking south depicting slopes which appears to be steeper than 1.5 Horizontal to 1 Vertical design slopes.

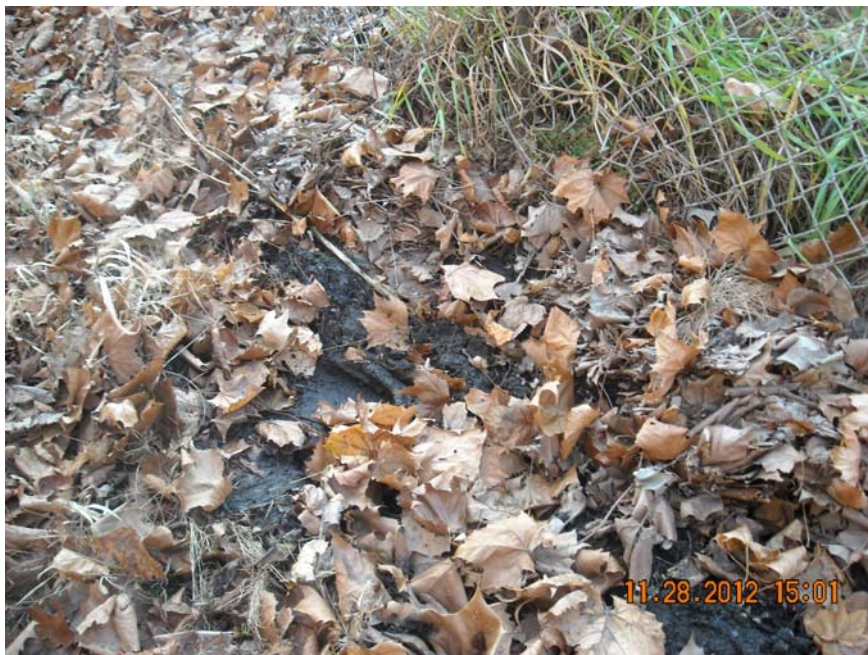
Picture of wet area along the east embankment of the BAP. Location of wet area is shown in Figure 1.

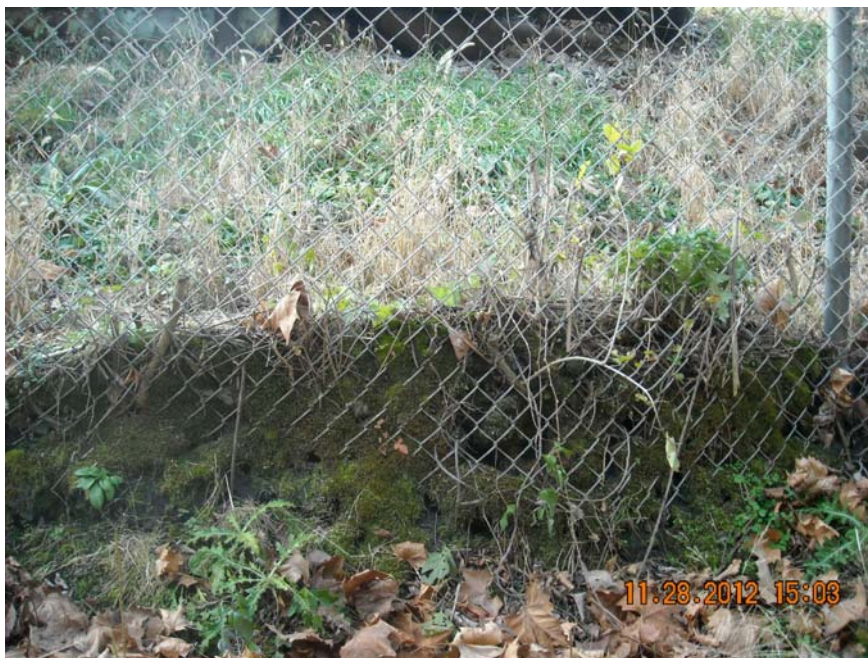
Photograph 4

Signs of soil accumulation along the BAP's east embankment perimeter fence.

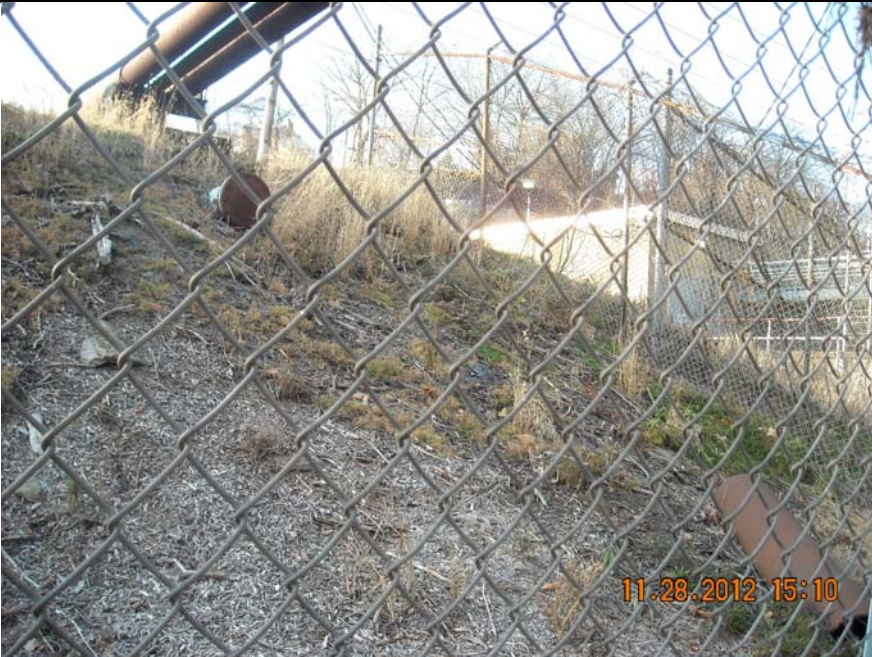
Date: 11/28/2012			
Location: South Embankment			
View of Emergency BAP's east slope, looking northwest. Note sparse vegetation.			
Photograph 6		 	
Date: 11/28/2012			
Location: South Slope			
View of the Emergency BAP south slope. Picture show what appears to be an animal burrow.
